Lessons Learned

We Make the Employee Communication for Your Major Incident

Contractor Killed - Storage Tank Explodes During Cleaning

Natural Gas Wellsite

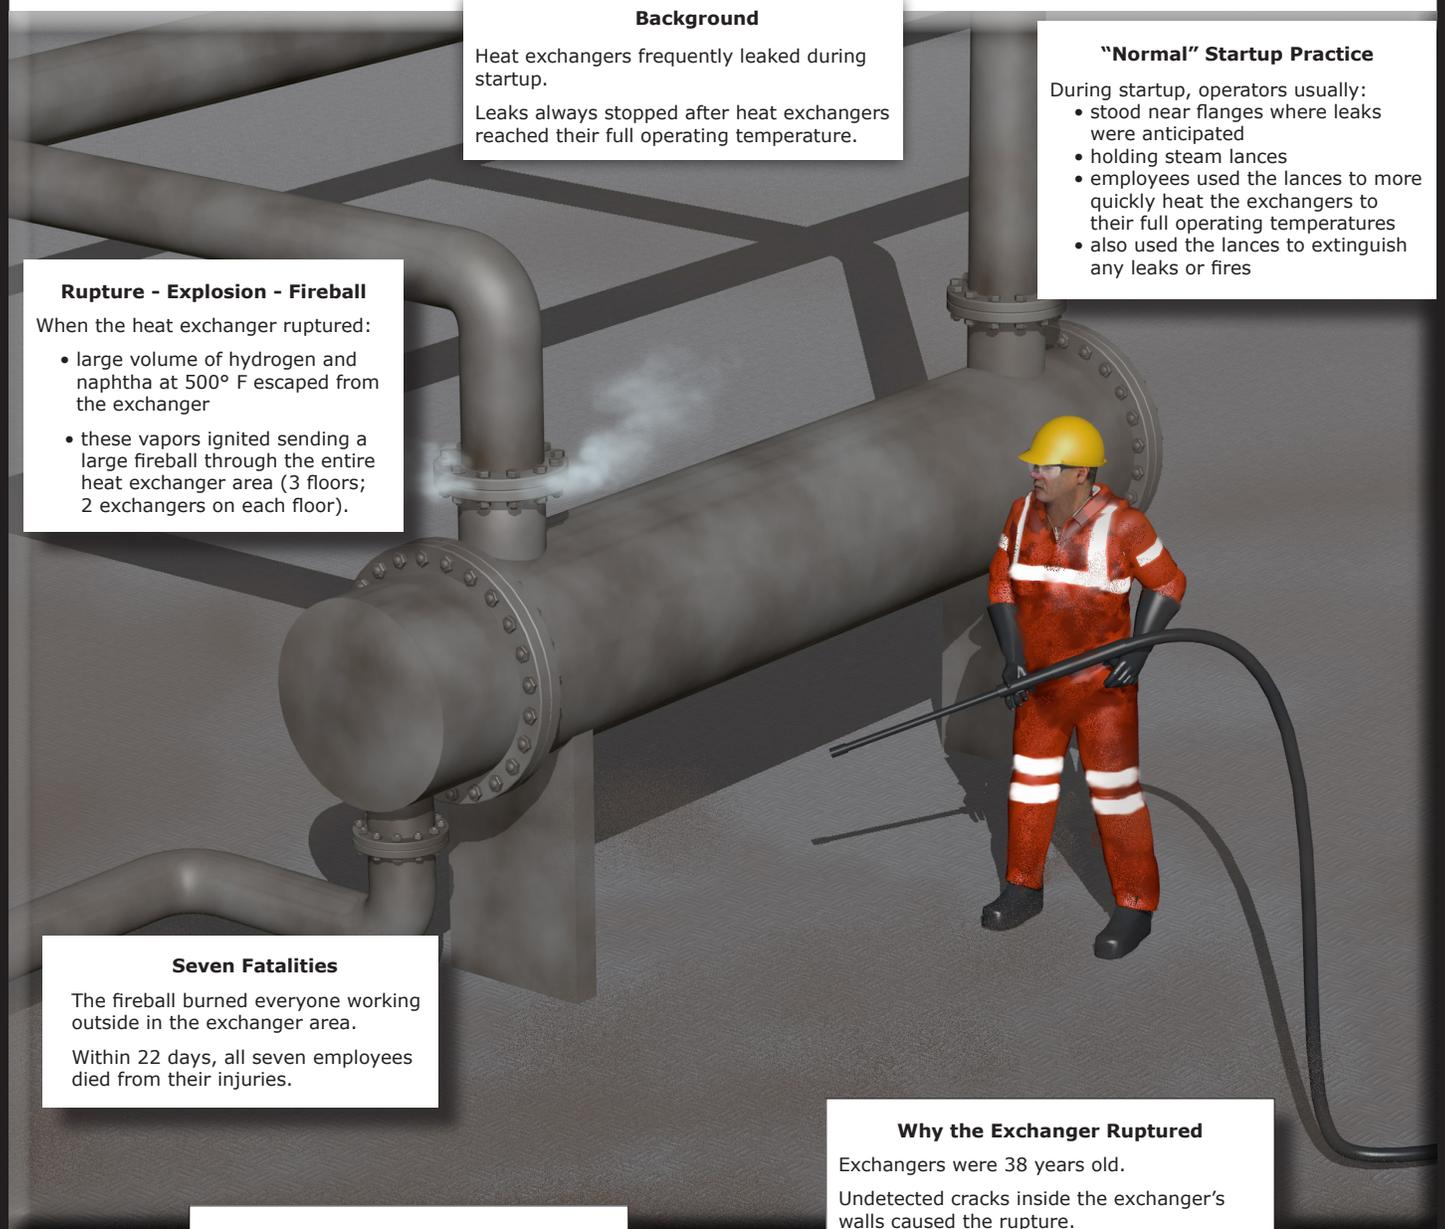
Heat exchanger in oil refinery exploded.
 Seven employees killed.
 Heat exchanger located in the refinery's catalytic reformer/naphtha hydrotreater unit (NHT).

- large volume of hydrogen and naphtha at 500° F escaped from the exchanger
- these vapors ignited sending a large fireball through the entire heat exchanger area (3 floors; 2 exchangers on each floor).

Exchangers were 38 years old.
 Undetected cracks inside the exchanger's walls caused the rupture.
 Operators using the steam lances did not contribute to the heat exchange rupture—the exchanger would have ruptured anyway.
 However, the large number of fatalities was due to the many employees working in the exchanger area during the startup.

Investigation showed the insides of the exchanger walls were cracked.

Cracks were caused by HTHA (high temperature hydrogen attack). The carbon steel walls were susceptible to HTHA.

Hydrogen added to the naphtha feed interacted with the carbon steel walls to create methane gas.

The methane gas was trapped inside the exchanger walls creating fissures and eventually larger cracks.

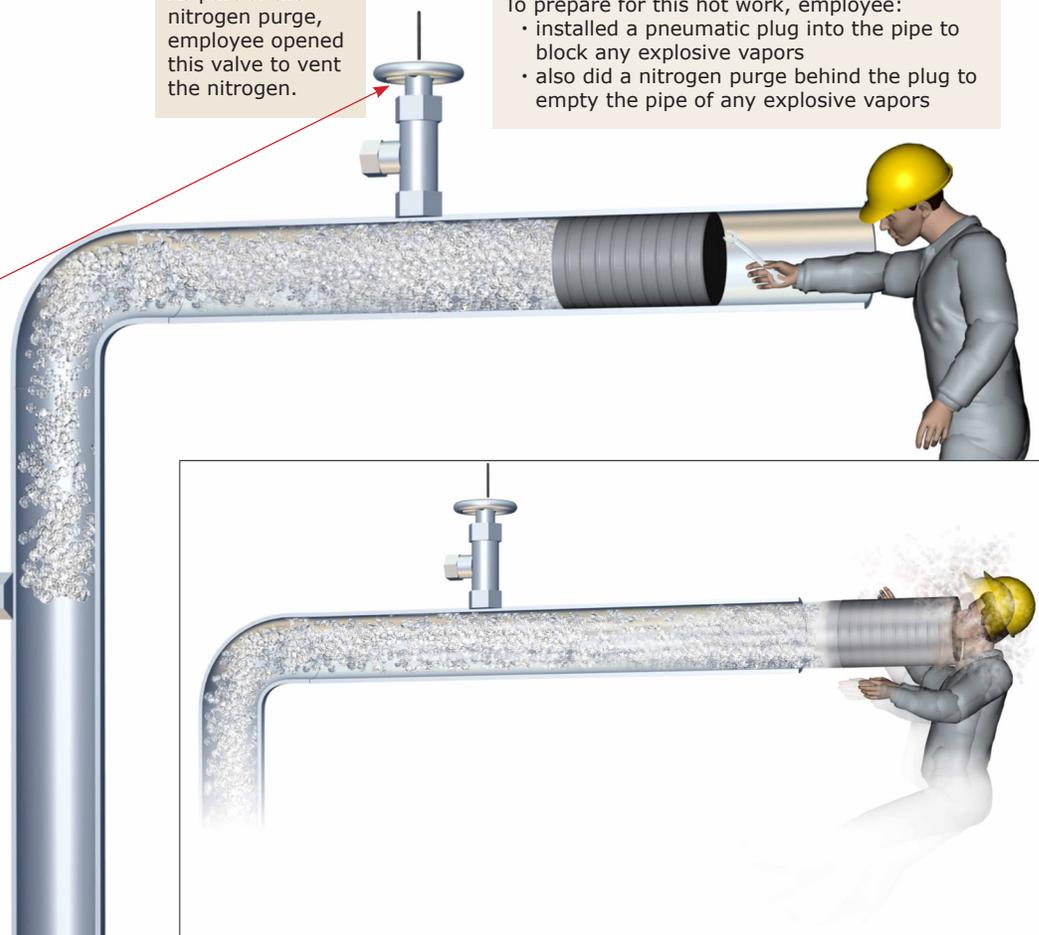
Employee was going to make a pipe tie-in. Welding was necessary.

- To prepare for this hot work, employee:
- installed a pneumatic plug into the pipe to block any explosive vapors
 - also did a nitrogen purge behind the plug to empty the pipe of any explosive vapors

As part of the nitrogen purge, employee opened this valve to vent the nitrogen.

During the purge, the control room operator remotely closed this valve—so nitrogen pressure began building up behind the plug.

Employee heard the plug move inside the pipe.
 The plug shifted to an incorrect position.
 Employee decided to deflate the pneumatic plug to reposition it.
 As the plug deflated, the nitrogen pressure that had built up behind the plug fired the plug, at high speed, out the open end of the pipe.
 The flying plug hit the employee in the head, and he died from the injury.

Maintenance team should have locked out the valve before beginning the purge.

If the valve was locked open, the control room operators would not have been able to remotely close the valve.

The plug moved inside the pipe because it was under-inflated.

- instructions were to inflate the plug to 35 psig
- the employee inflated the plug only to 15 psig
- that's why the plug moved, had to be deflated, and then repositioned

When properly inflated, the plug was designed to withstand a backpressure up to 12 psig.

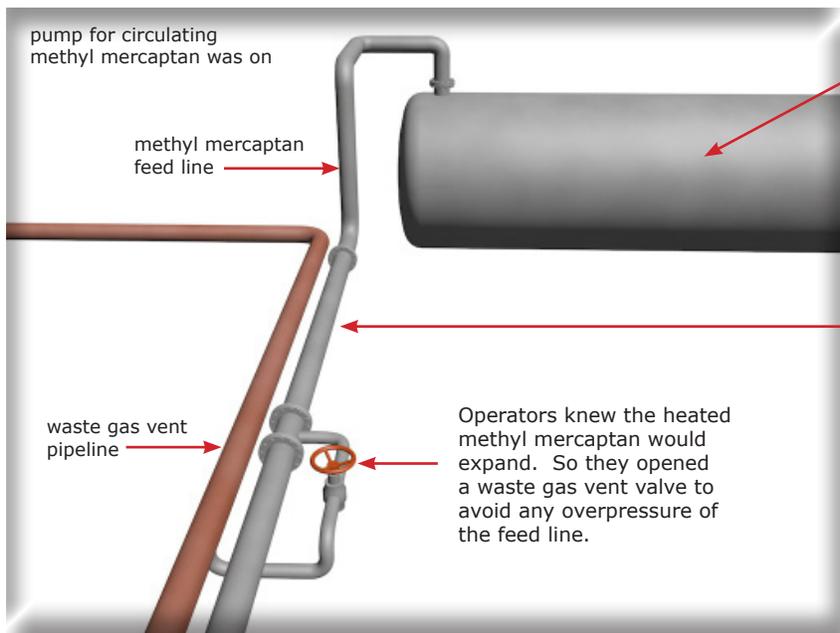
During normal operations, methyl mercaptan is pumped from a storage tank through a feed line into the process unit.

During the shutdown, water was accidentally pumped into the methyl mercaptan storage tank. When combined with water, methyl mercaptan will create a hydrate (freeze) at relatively warm temperatures (50°F).

Frozen methyl mercaptan plugged the feed line and blocked the flow into the process unit.

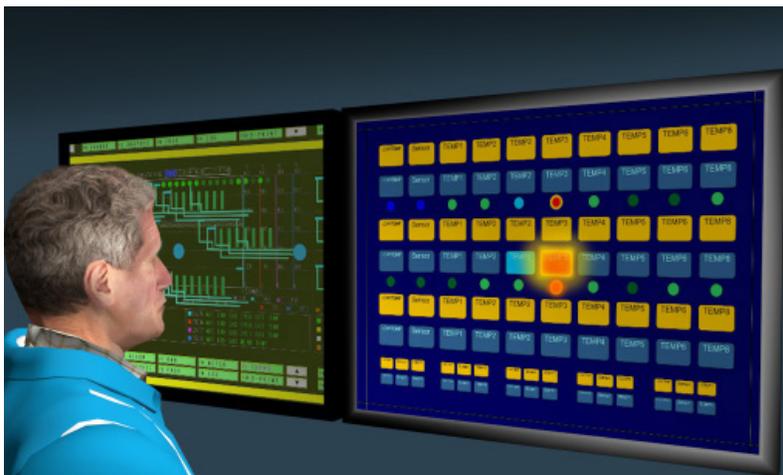
The incinerator at the end of the waste gas pipeline was installed four years earlier.

After installing the incinerator, high pressure alarms in the waste gas pipeline happened frequently.

This alarm had become "normal."

Almost daily, employees cleared this alarm by opening a drain valve on the 3rd floor of the manufacturing building.

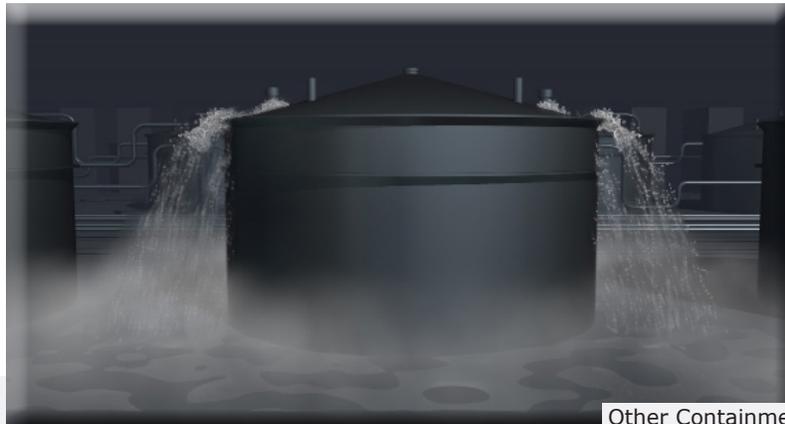
Automatic Tank Gauging Failed

- 2½ hours before the explosion, the ATG gauge "flatlined"
- gauge stuck and stopped showing the rising petrol level

- this particular ATG servo gauge failed frequently (14 times in the previous 3 months)
- the weight would get stuck and the drum would no longer lower and raise the weight as the fluid level changed—operators called this “flatlining”
- operators could sometimes fix the flatlining by getting the drum to raise the weight to the very top and then lowering the weight again until it hit the fluid level (they called this “stowing”)
- unfortunately, the site did not keep an up-to-date fault log, so the eight supervisors working at the site did not know how unreliable the gauge had become

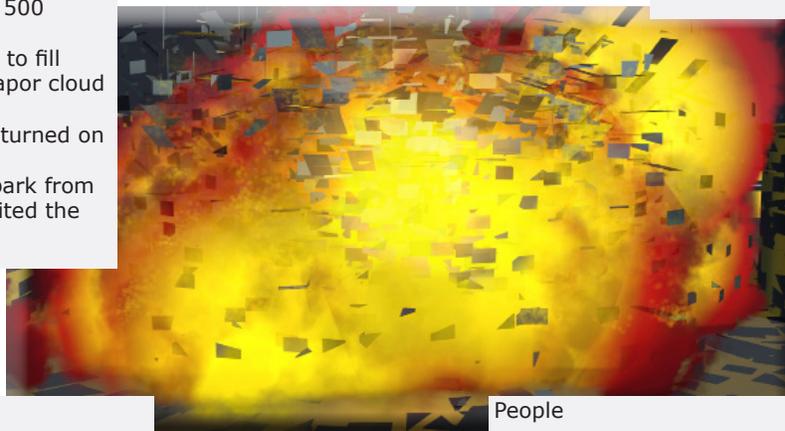
Explosion

- measured 2.4 on the Richter scale
- biggest peacetime explosion ever recorded in the UK

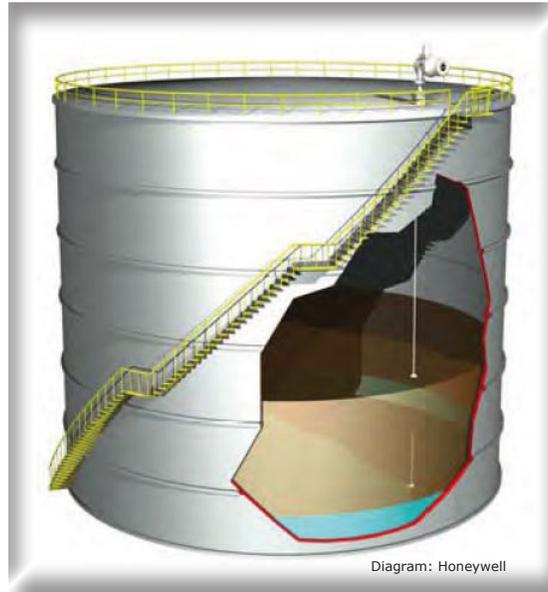
How it Works - ATG

- an ATG servo gauge continuously measures the fluid level in a tank
- a weight is suspended by a wire, the wire is spooled around a drum
- the drum turns and lowers the weight into the tank
- when the weight hits the liquid, the weight becomes lighter
- motor detects the lighter weight and records the distance based on the number of turns used by the drum to lower the weight
- the drum keeps the weight resting on the liquid surface and gives a continuous reading of the fluid level

What Went Wrong - ATG
