Communication Best Practice Lessons Learned

Communication Best Practice - Lesson Learned

Contractor Killed When Storage Tank Explodes
Natural Gas Wellsite

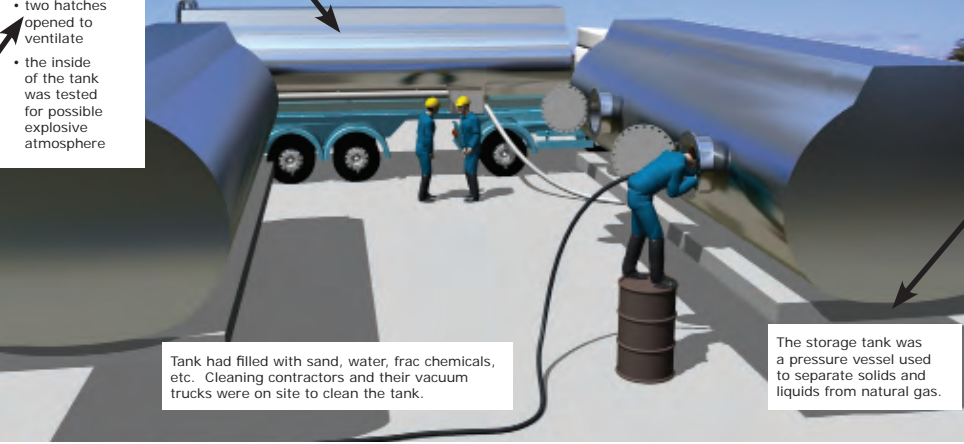
To prepare for cleaning, tank was:

- isolated from the wellhead
- two hatches opened to ventilate
- the inside of the tank was tested for possible explosive atmosphere

Contractor was using a high-pressure water hose to clean a storage tank.

Tank had filled with sand, water, frac chemicals, etc. Cleaning contractors and their vacuum trucks were on site to clean the tank.

The storage tank was a pressure vessel used to separate solids and liquids from natural gas.

While the contractor was leaning inside the open hatch (hosing sand toward the drain) the tank exploded.

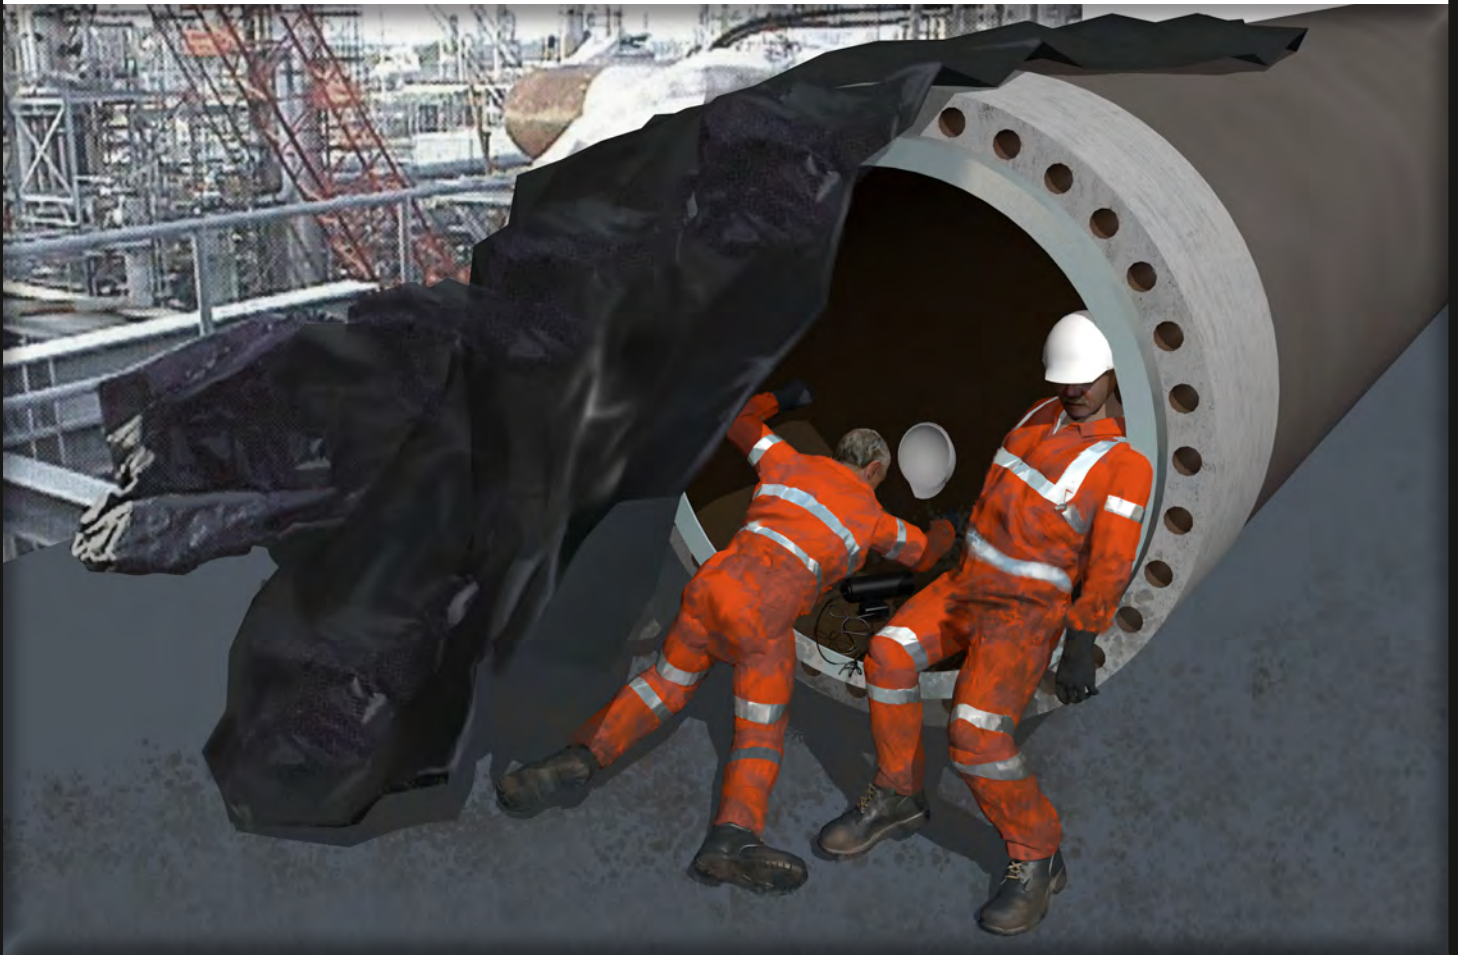
Employee and supervisor cleaned the flange on a 48 inch pipe.

They did a black light inspection looking for any left over dirt or grease on the flange surface.

To see better in the bright sunlight, they covered the pipe opening with a black plastic sheet and climbed underneath.

The supervisor forgot he ordered a nitrogen purge the night before.

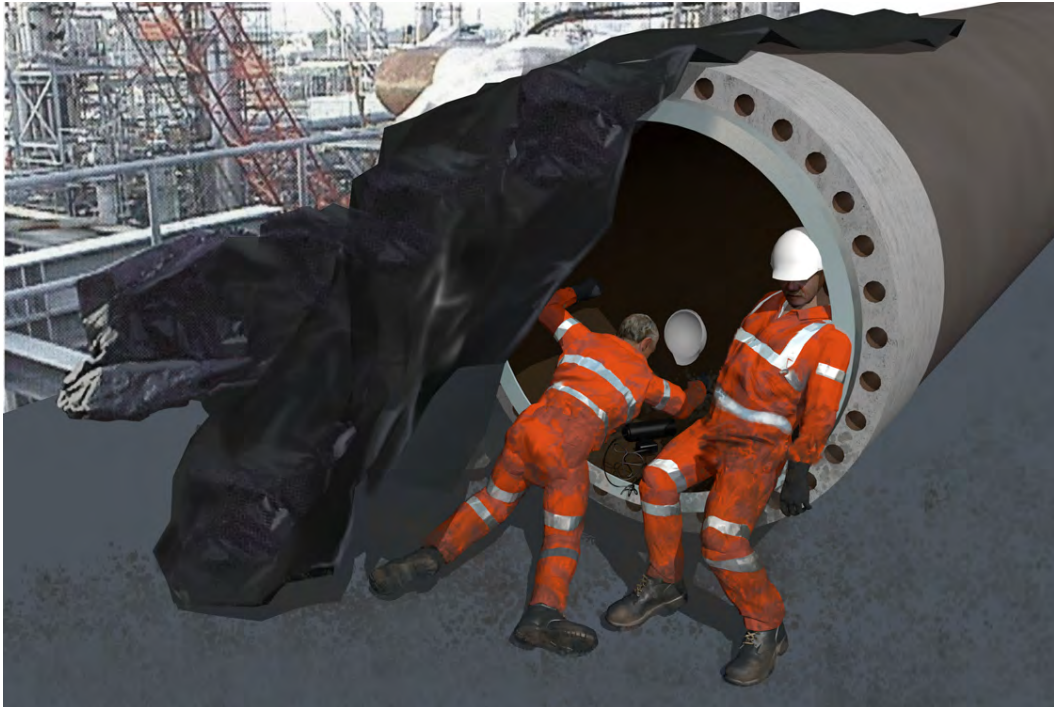
During a turnaround, an oxygen feeder was removed for cleaning. This left a 48-inch pipe opening.

After cleaning the flange, the supervisor and employee did a black light inspection. Black light will reveal left over dirt or grease.

In the bright sunlight, they could not see the black light results.

So, they found a black plastic sheet, covered the pipe end, and they climbed underneath.
